3. REPORT TITLE A STRUCTURAL STABILITY-MECHANICAL BEHAVIOR CORRELATION IN EUTECTIC Al-CuAl ₂ (The Role of the Interface on the Mechanical Behavior of Metal-Matrix Composites)

A STRUCTURAL STABILITY-MECHANICAL BEHAVIOR
CORRELATION IN EUTECTIC Al-CuAl_2

Technical Report #8
Office of Naval Research
Arlington, Va.

Drexel University
Department of Metallurgical Engineering
Philadelphia, Pennsylvania 19104

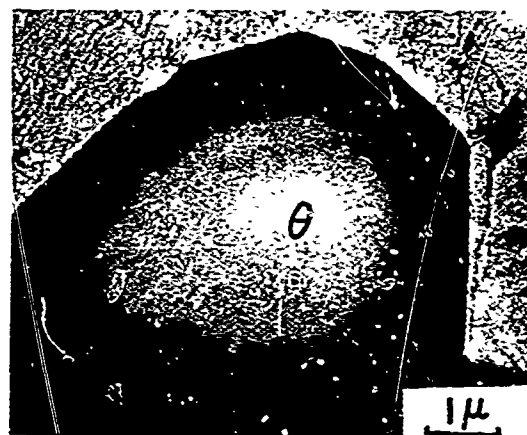
Figure 8

TEM illustrating faceting of the CuAl₂ (θ) phase (a) transverse section,
directionally solidified; (b) transverse section exposed 100 hours at 530°C.

A more detailed picture of the coarsening processes is gained from the TEM study; representative micrographs following exposure at 530°C are shown in figures 7 and 8. These observations confirm that coarsening initiates at faulted regions such as terminal lamellae and show that the θ platelets recede from the original fault line with an accompanying thickening of adjacent θ platelets, figure 7(a). The preferred crystallography of the two phases is not altered during coarsening and low-angle tilt boundaries are preserved in order to maintain the original misorientations at the faults. In figure 7(c), the receding θ platelet carried the low-angle boundary along with it. After 100 hours at 530°C the structure spheroidizes and faceting of the θ phase is observed. Figures 8(a) and 8(b) compare the form of terminal lamellae before and after elevated temperature exposure. SEM of fracture surfaces confirms these microstructural features of the coarsened structure and also illustrates the increased contiguity of the θ intermetallic, section C.

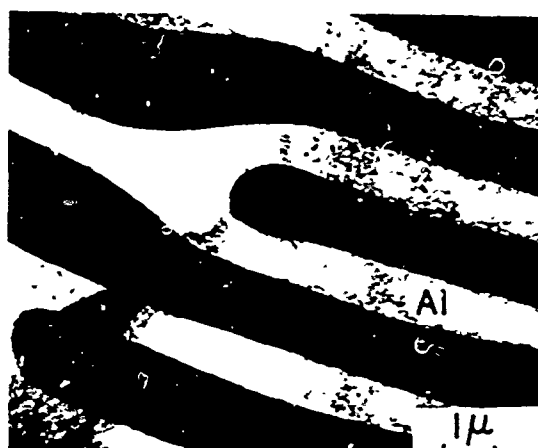
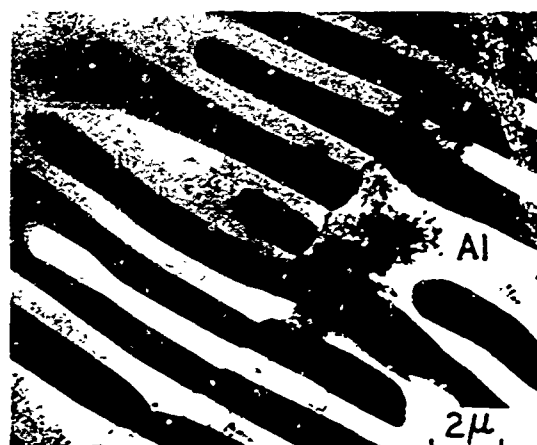
Figure 7

TEM showing coarsening in Al-CuAl_2 ; transverse sections; (a) 10 hours at 530°C ; (b) 10 hours at 530°C ; (c) 100 hours at 530°C .

The dislocation substructure in the α phase is relatively uniform, figure 7. However, in comparison to the directionally solidified condition (figure 4), the dislocation density is significantly higher (figure 7). This higher dislocation density following elevated temperature exposure is tentatively attributed to plastic flow of the α phase on slow cooling in order to relieve residual stress. There is no evidence of incoherent precipitation in the α phase.

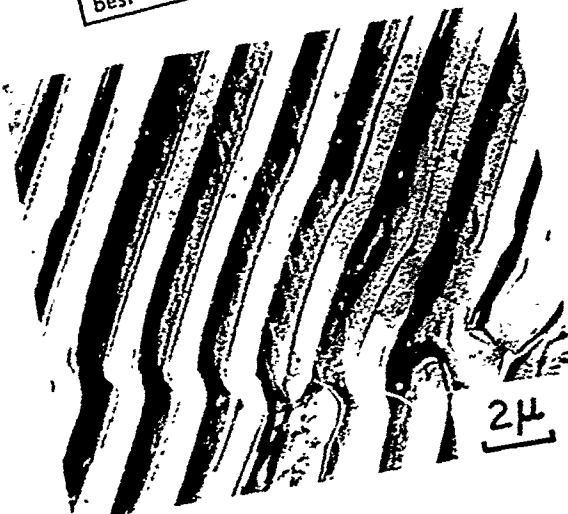
Figure 12

Electron fractographs of Al-CuAl_2 in the directionally solidified condition;
tensile failure.

Electron fractography and SEM confirm these structural characteristics of the fracture process. Representative electron fractographs (from two-stage replicas) of the composite in the directionally solidified condition are compared in figure 12. Transverse cleavage of θ platelets and necking of the α -phase to a knife edge is illustrated in figure 12(a). An example of transverse cleavage followed by shear of the α -phase is seen in figure 12(c). Cleavage steps on the θ phase can also be observed in some areas of the fracture surface, figure 12(b). The specific surface detail on the CuAl_2 phase is probably a function of the orientation of the θ platelets relative to the local path of fracture.

The mode of fracture of Al-CuAl_2 is similar in the directionally solidified condition and following elevated temperature exposure. In stage II deformation, premature cracking of θ platelets leads to localized void formation. Cracks also appear in adjacent θ lamellae due to stress concentrations. Void coalescence to macrocracks involves shear of the α phase or tensile necking of the α phase between θ lamellae, figure 11(a). Propagation of the unstable crack is followed by necking of the α phase to a knife edge, figure 12(a).
